Manhole Inspection Summary

Manhole # S31AA_039MH

Insp Date: **1/27/08 1:24 PM**

Location Address: **735 EUTAW ST**

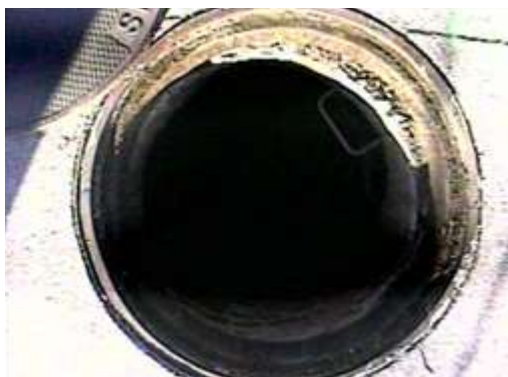
Defect 1

Offset: **2** (in.)

FRAME OFFSET

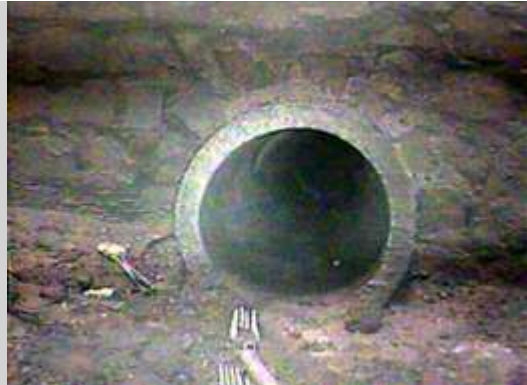
12 O'Clock Outflow

8 in. Circular Gravity Sewer
Pipe Out @ 12 O'Clock

Pipe Material: **Clay** ☐ Pipe Lined

Infiltration: **None** Pipe Seal Cond: **Sound**
